USAFA-TR-78-11

**ENVIRONMENT, DISASTER, AND RECOVERY:
A LONGITUDINAL STUDY OF THE 1970 GEDIZ EARTHQUAKE
IN WESTERN TURKEY.**

NOV 1978

FINAL REPORT

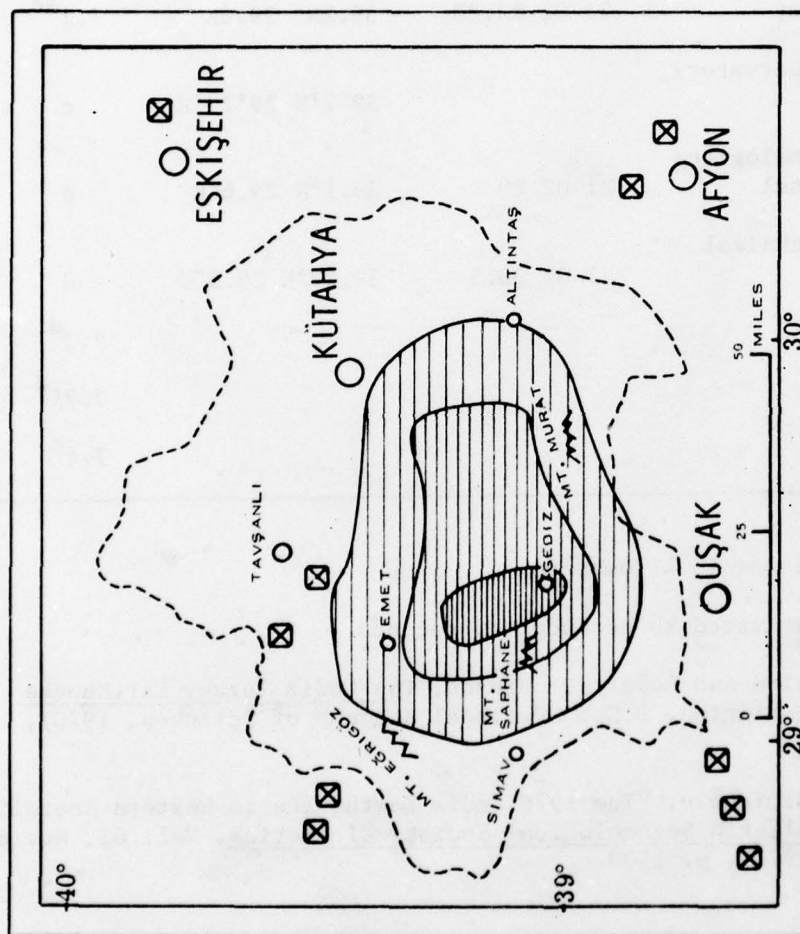
FIGURE 10

INTENSITY OF THE GEDİZ EARTHQUAKE DAMAGE

- AREA OF HEAVIEST DAMAGE
- ▨ DAMAGE LESS SERIOUS AND VARIED OVER SHORT DISTANCES
- ▤ DAMAGE IS LESS SERIOUS, LITTLE STRUCTURAL DAMAGE
- ⊠ HISTORICAL EARTHQUAKES OF MAJOR INTENSITY

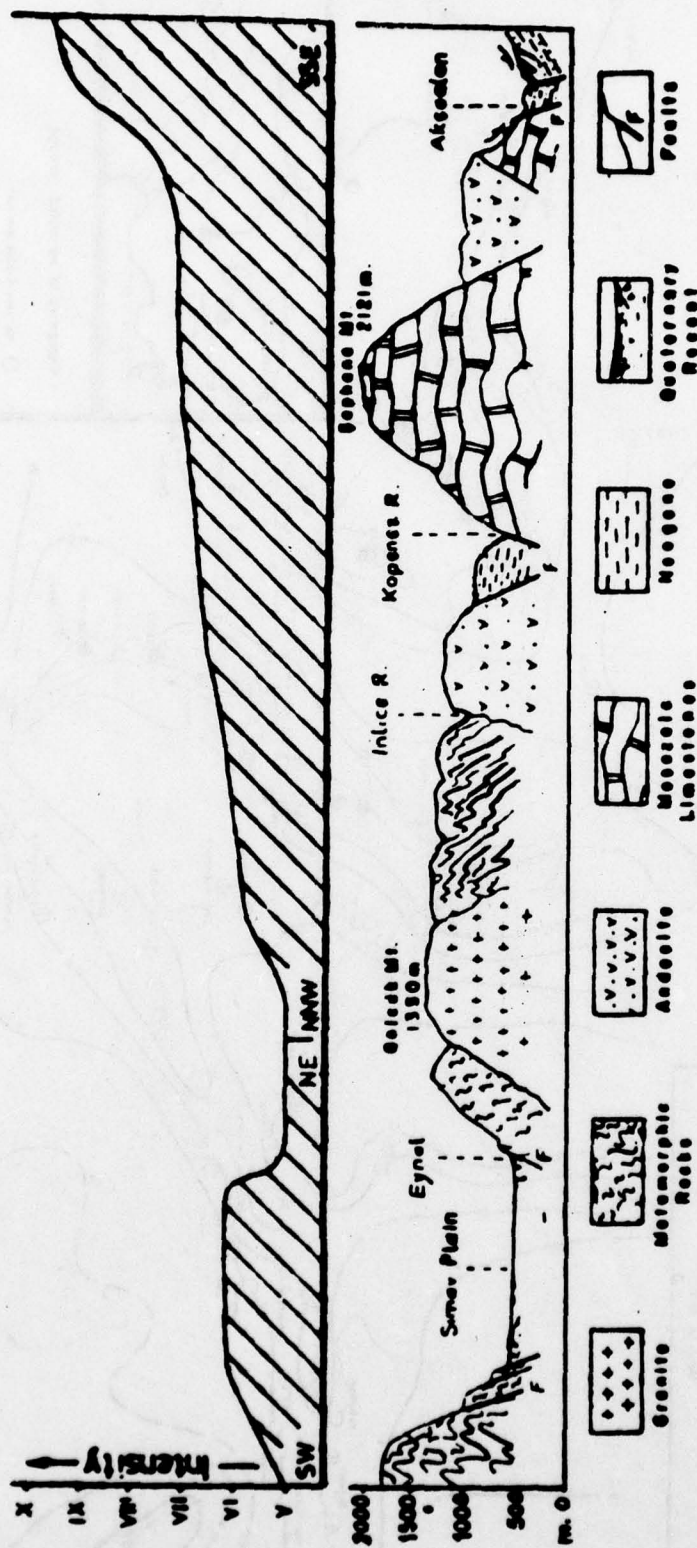
FIGURE 12

RELATIONSHIP OF INTENSITY TO GEOLOGY

of Gediz, where reinforced concrete buildings received major damage. Large areas between the plant and Gediz received very little force and damage, thereby suggesting that strain energy was, in fact, transmitted deep within bedrock until focused to the surface near the plant.²⁷

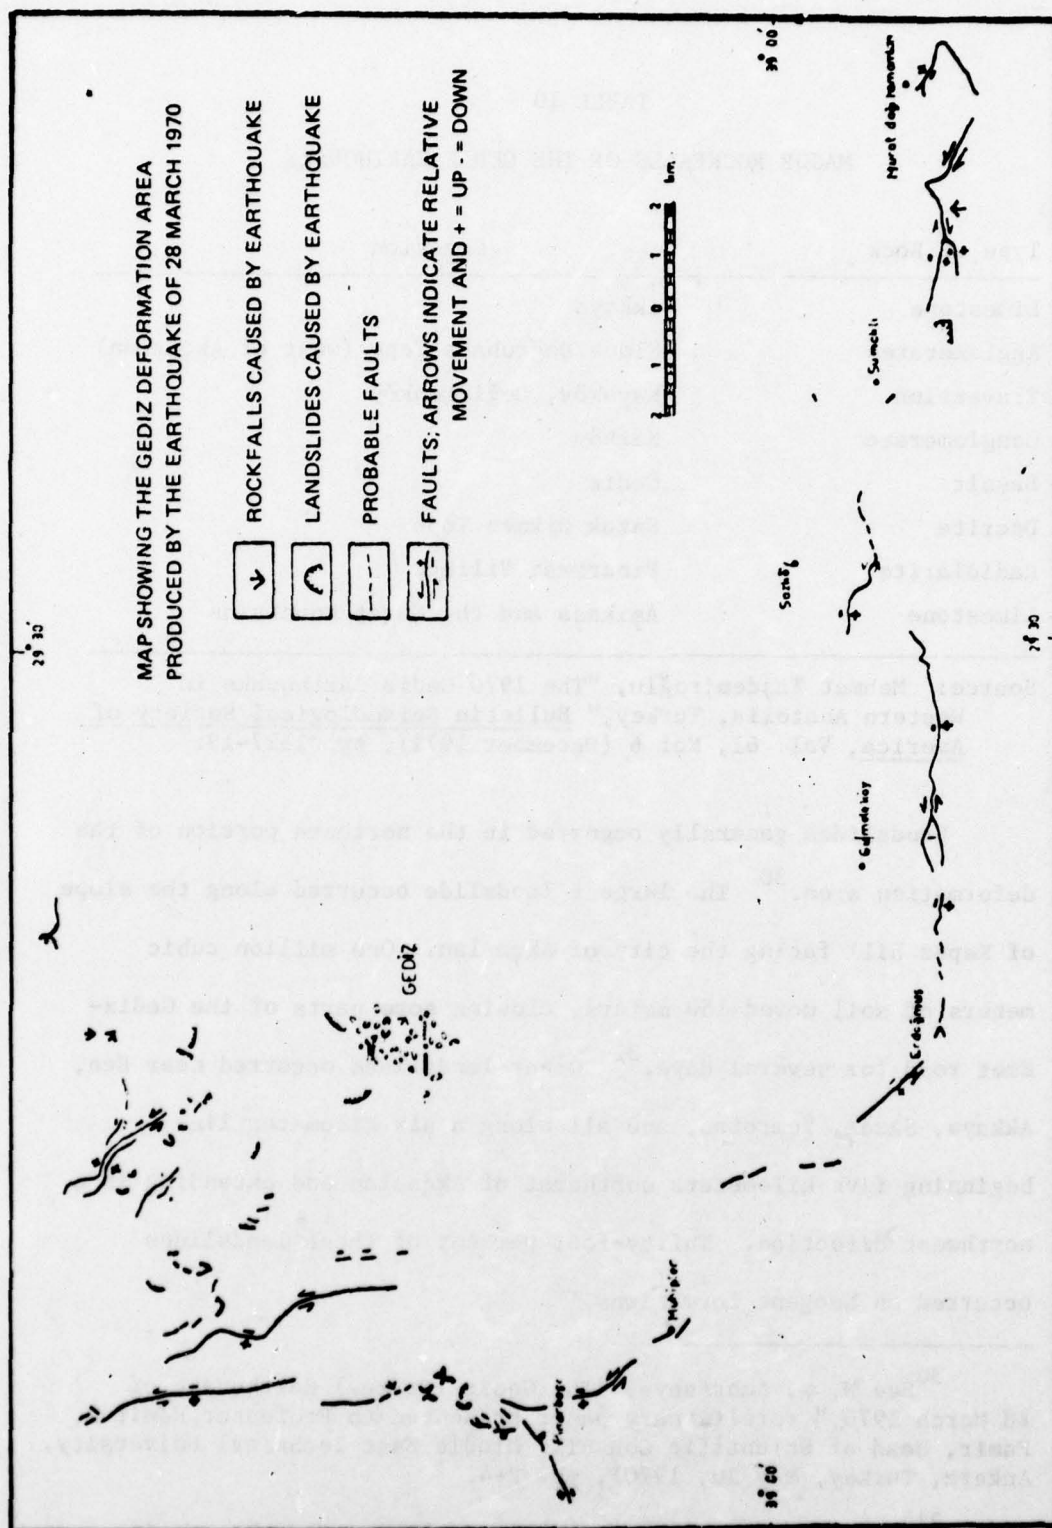
FIGURE 13

Rockfalls occurred throughout the deformation region (Figure 13). There was no general direction or type of rock formation associated with the quake. Table 10 lists the many types of rock that fell during the Gediz earthquake.

PHYSICAL EFFECTS

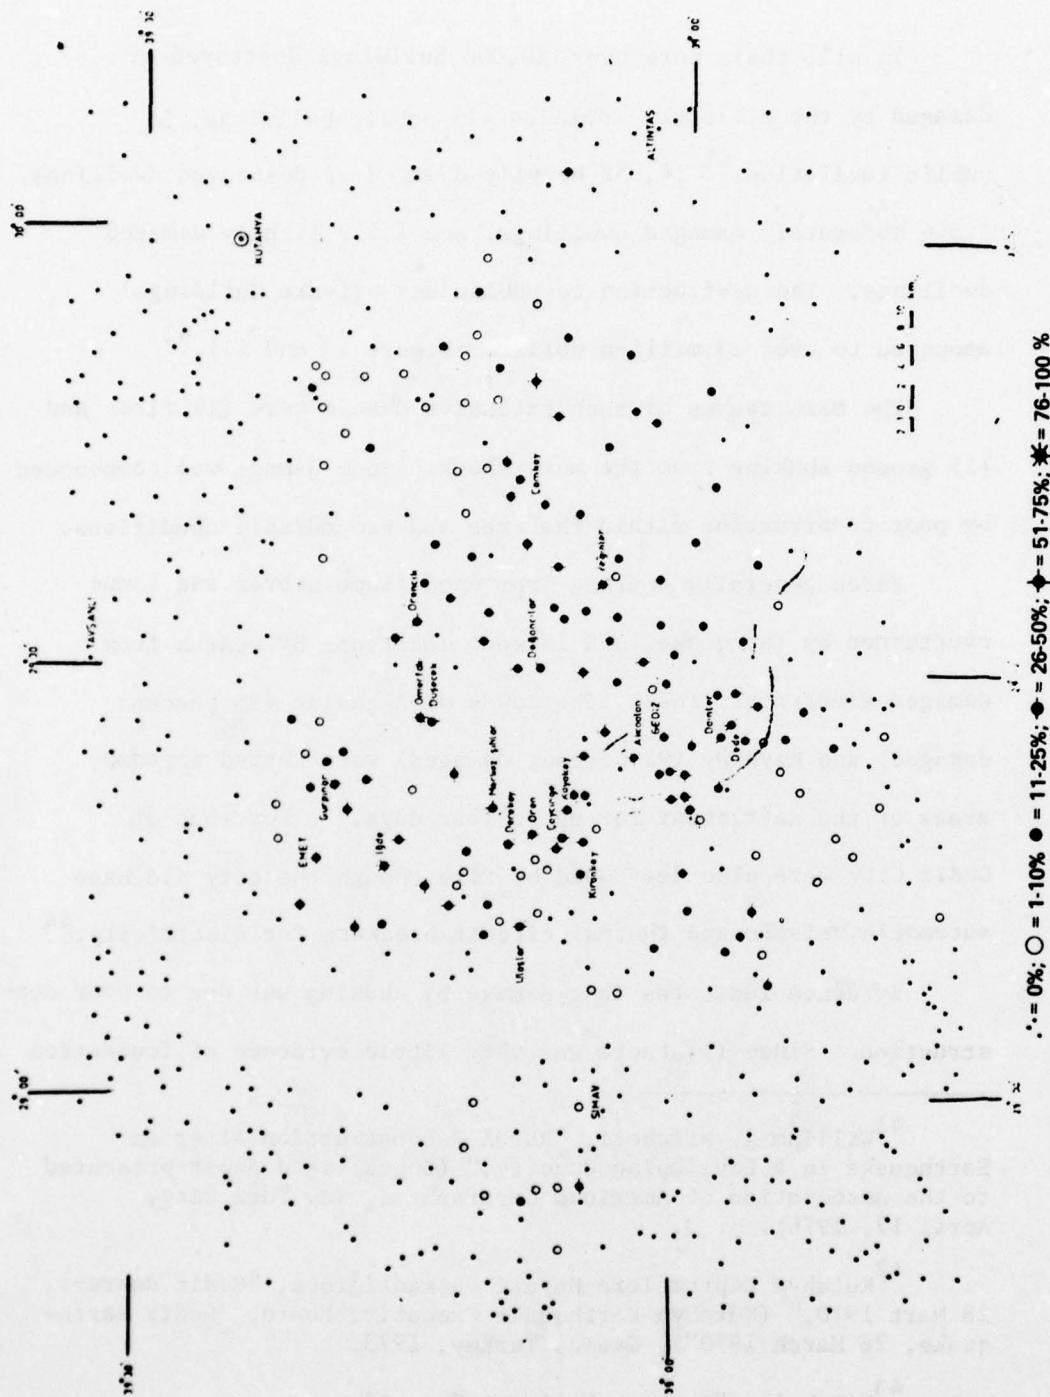
DAMAGES TO VILLAGES IN THE GEDİZ AREA

• = 0%; ○ = 1-10%; ● = 11-25%; ◆ = 26-50%; ♦ = 51-75%; ★ = 76-100 %

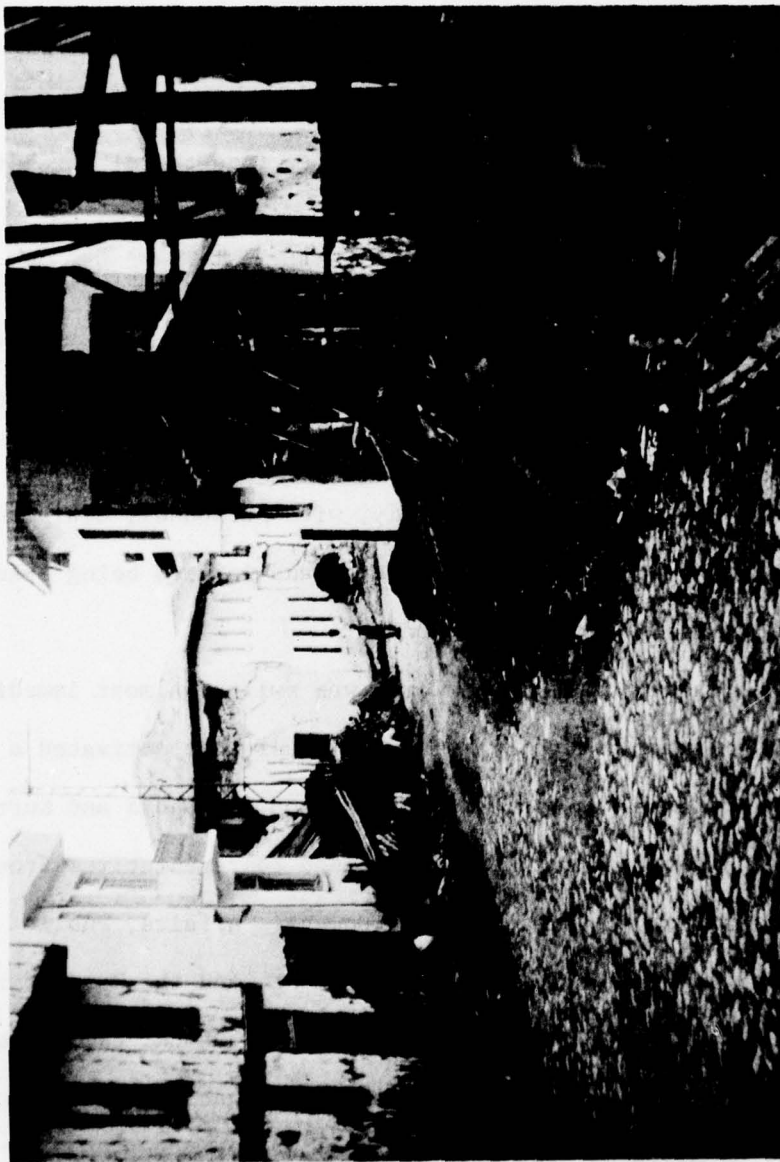
Figure 19

This major street in old Gediz was cleared
within a few days after the disaster.

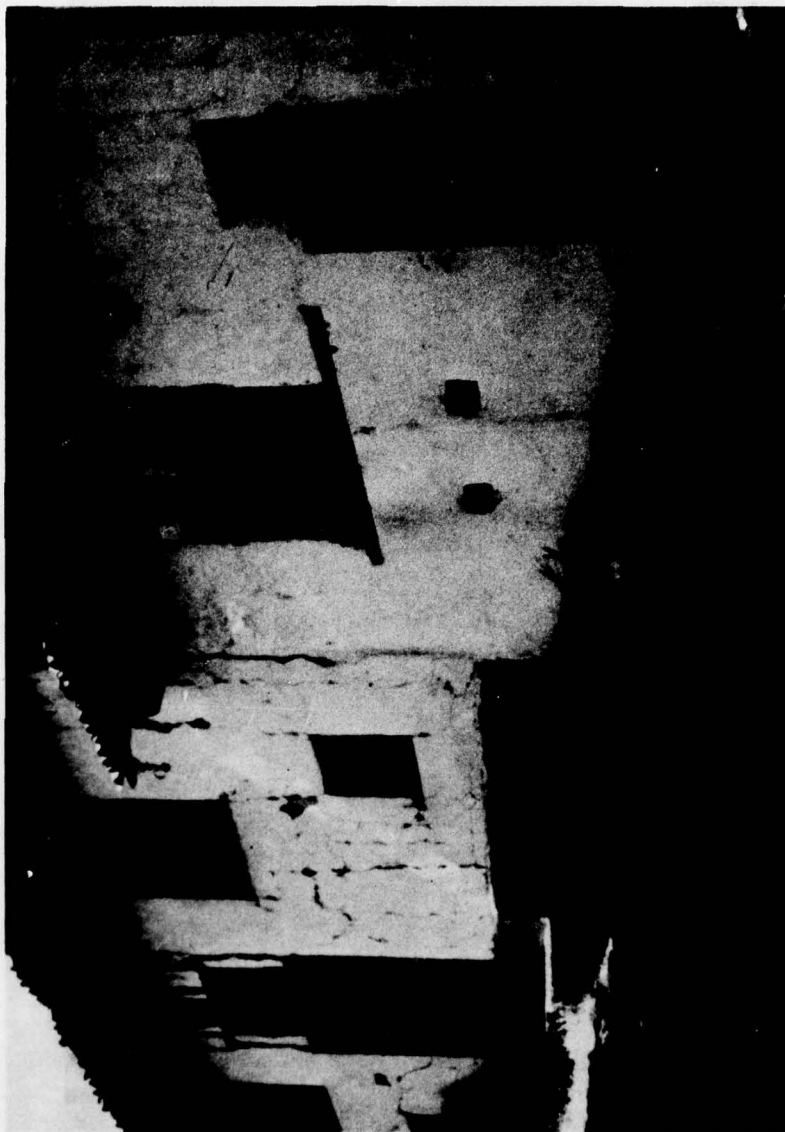
FIGURE B-4
Inhabited houses in old Gediz (1978)

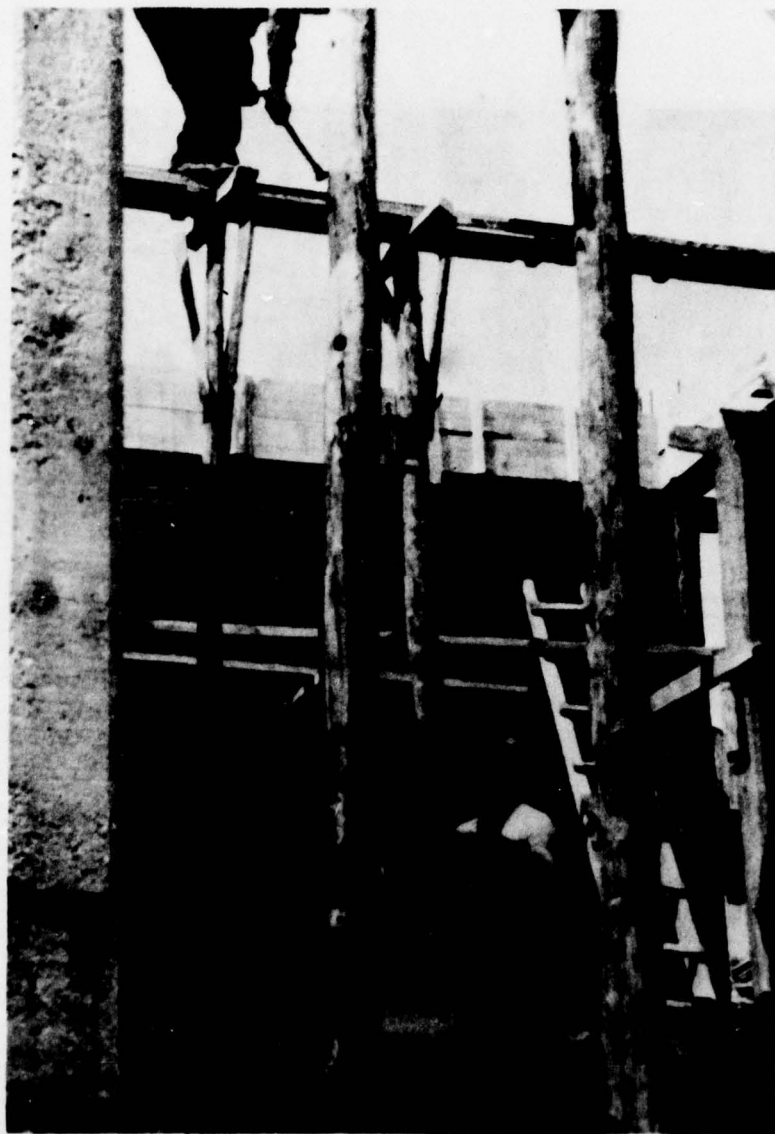
FIGURE B-8

Construction continues in old Gediz (1978)
